Earth architecture conservation training programme Khiva - Uzbekistan

Practical training report

Sebastien Moriset, CRAterre | April 2022

Training organised with the Mamun Academy, Khiva, from the 28th of March to the 7th of April 2022

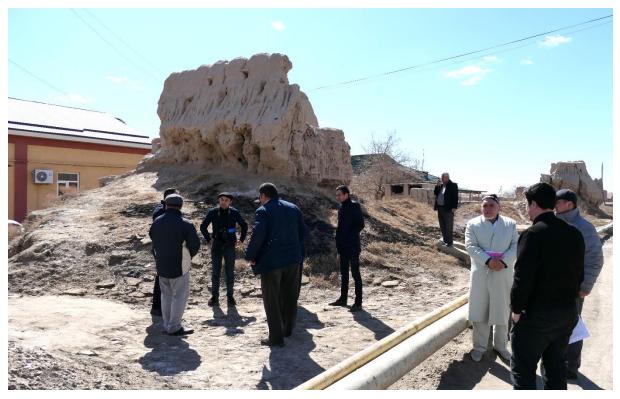
Ruined tower of Deshan Kala city wall where the on-site training took place

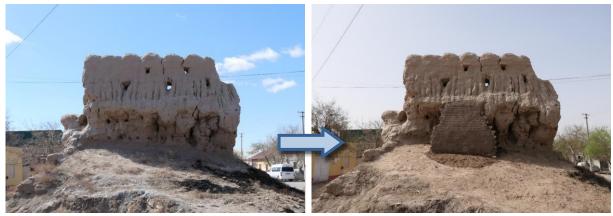
Tower before and after intervention

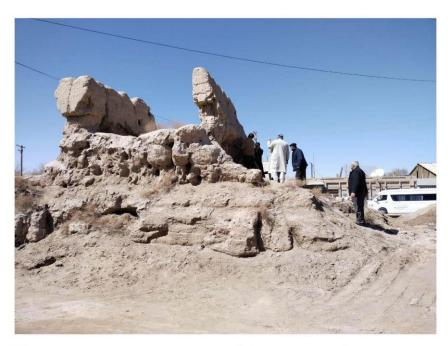
Обидани диагностика қилиш бўйича дастлаб аудиторияда маслахатлашиб олинди ва жойига чиқиб бевосита кўздан кечирилди. Кўздан кечиришда деворининг кунгара қисми танлаб олинди. Девор кунгурасининг сақланиш даражаси 30...40% даражада бўлиб, ўта носоз холатда. Носозлик сабаблари қилиб:

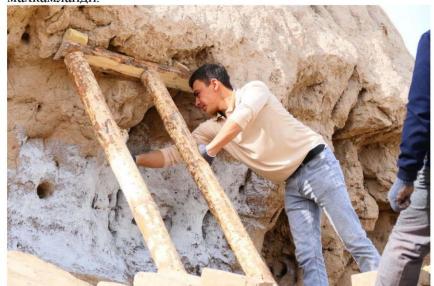
- 6. Пишиқ ғишт териб бўлгандан сўнг ёғоч тиргаклар мустаҳкам қилиб икки жойида ўрнатилди. Ушбу ёғоч тиргаклар янгидан қилинадиган деворнинг ичида қолиб кетишининг ҳисобга олган ҳолда ўрнатилди. Бунинг учун янги деворнинг ташқи контурларини аниқлаш мақсадида деворнинг эски қисми билан унинг сақланиб қолган қисмига унинг асл шаклини такрорлайдиган арматурадан шаблон андазаси ишланиб маҳкамланди.

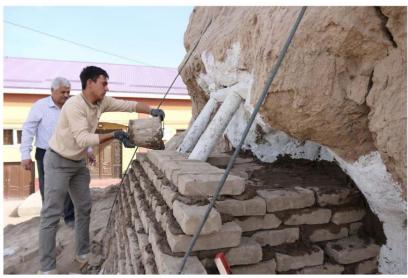
7. Пишиқ ғишт терими билан хом ғишт терими ўртасига гидроизоляция вазифасини бажарувчи рубероид қатлам қўйилиб, хом ғишт терими бажарилди. Терим ишлари давомида пишиқ ва хом ғиштларнинг сув шимувчанлиги аниқлаб борилди.

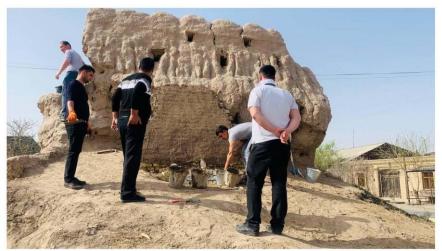
Семинар тренинг навбатдаги иш кунида олдинги куни тайёрланган лой қоришмаларини тобига келганлиги боис бевосита қалъа деворларига олдиндан белгилаб олинган участкаларга суваб чиқилди ва уларнинг ҳар қайсининг таркиби бўйича сувалган участкаларга белгилар қўйиб чиқилди. Шу билан бирга лой намуналаридан ўлчам 10x10x5 бўлган қолиплар тахтадан ишланиб, ушбу қолипларга қуйиб қуритишга қўйилди.
